# Engine power loss and low-speed rejected take-off, involving Airbus A320-232, registered VH-VFF

Brisbane Airport, Queensland, on 23 October 2020

## **ATSB Transport Safety Report**

AO-2020-058

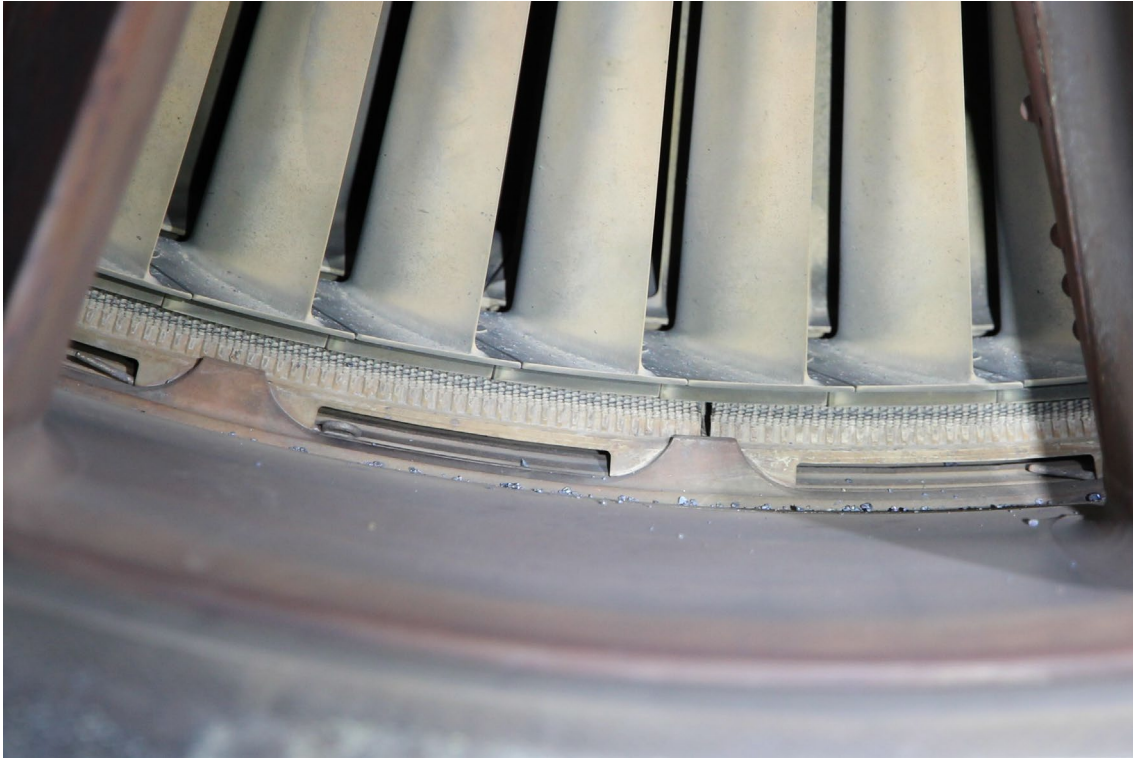
The captain cancelled the flight and the aircraft was taxied back to the airport gate where both engines were shut down. Immediately after the passengers had disembarked, engineers reported finding small balls of metallic debris in the tailpipe of the right engine (Figure 1). A review of recorded data indicated the right engine had surged.

**Figure 1: Debris in right engine tailpipe**

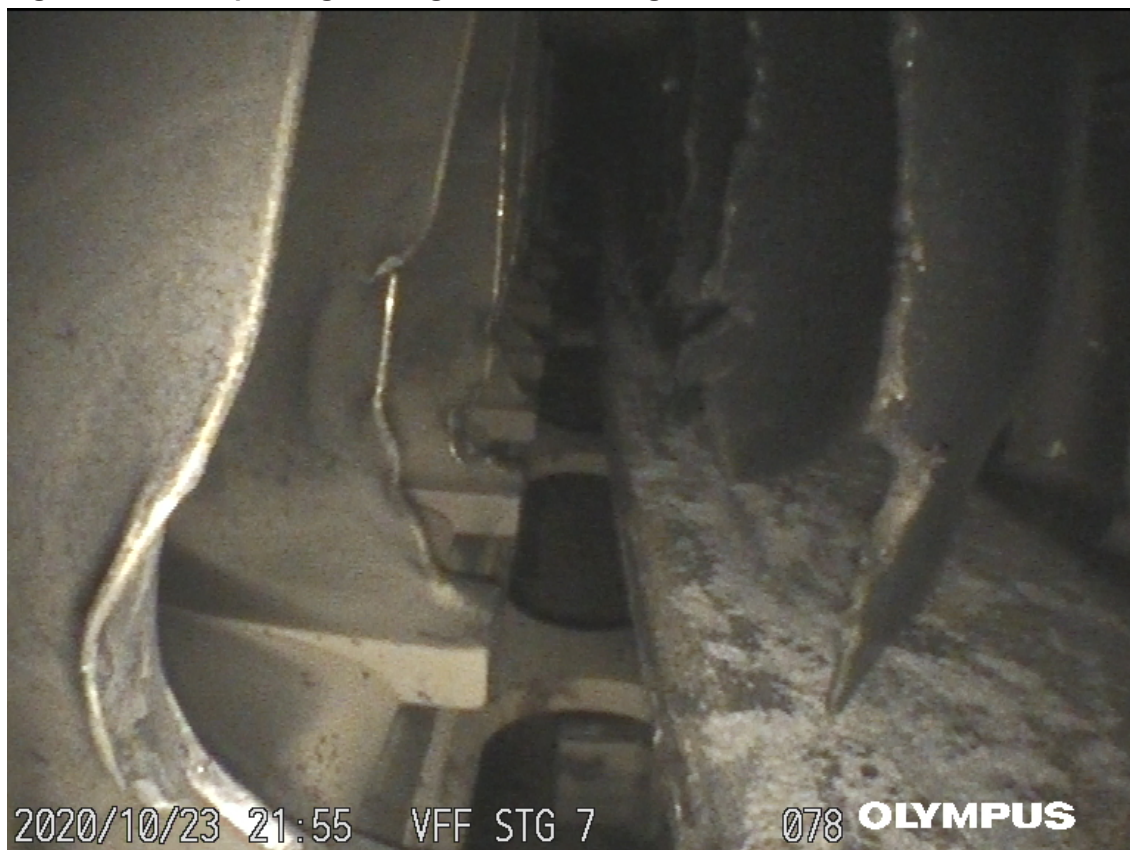
A borescope inspection of the right engine found there was damage to HPC stages 3, 5, 6, 7, 8 and 9 (Figure 3) consistent with foreign object damage (FOD).<sup>6</sup> As the damage was outside maintenance manual limits, the engine was removed from the aircraft and sent for a teardown inspection.

**Figure 3: Borescope image of stage 7 HPC and stage 8 stator vanes**

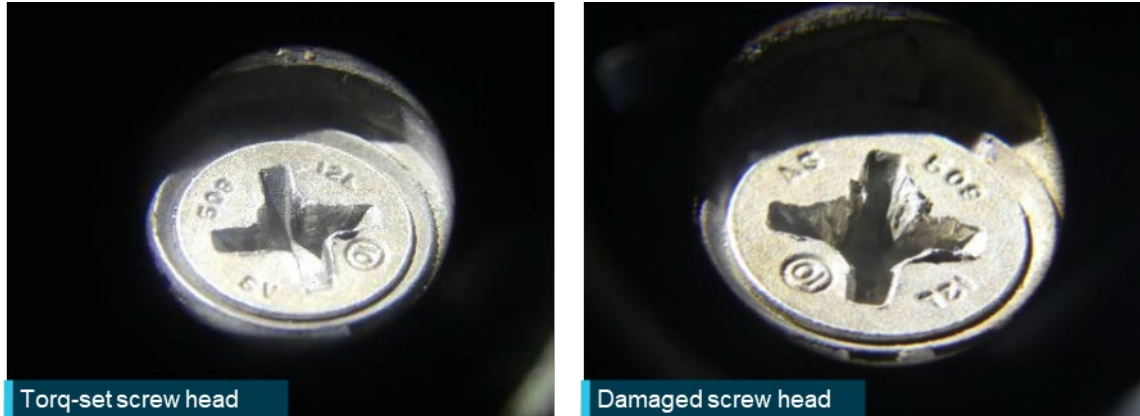
- The fan blades and LPC contained no visible damage.
- The rear fairing to the LPC bleed valve mechanism was in place but had one Torq-set screw with a damaged head. Although of an incompatible shape, testing showed that due to the damage, the head would also accept a Phillips screwdriver tip (Figure 4).

**Figure 4: Interstage screw heads**

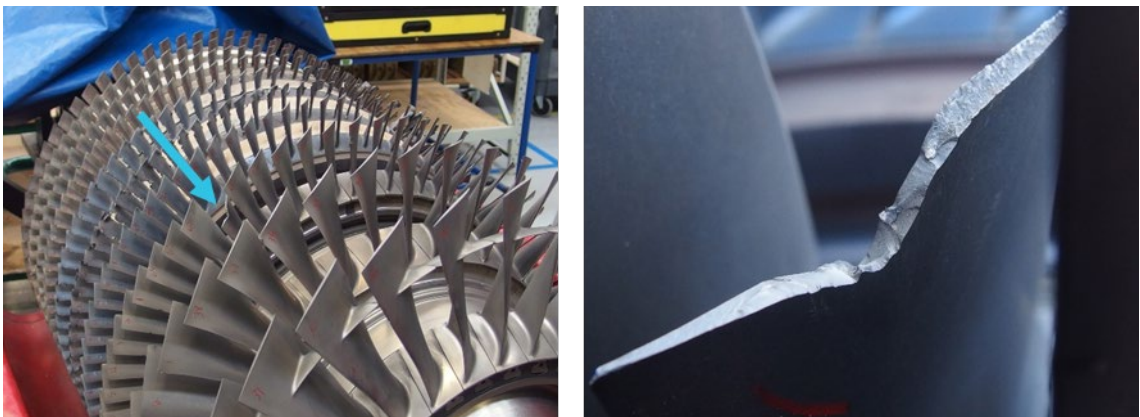
- In the HPC section, rotor blades (blades) and stators (vanes) in stages 3 and 4 contained dents and minor tears.
- Approximately half of one stage 5 blade (Figure 5) and a whole stage 6 vane (Figure 6) were missing and had failed due to cyclic fatigue. Some of the remaining stage 5 blades exhibited tip curl,<sup>7</sup> dents and/or missing material.

**Figure 5: Stage 5 blade fatigue failure**

A failure analysis was conducted by an engine maintenance facility. The fractured stage 5 blade showed minor leading edge mechanical damage at approximately half span, which initiated a fatigue crack that propagated through approximately two-thirds of the chord. The remaining third of the chord failed in material overstress.

Both fatigue fracture surfaces displayed fine striations consistent with a high frequency load spectrum, likely from aerodynamic vibrations. While no fatigue growth rate analysis was conducted, based on similar occurrences, it was estimated the components took tens of flight cycles to fail.

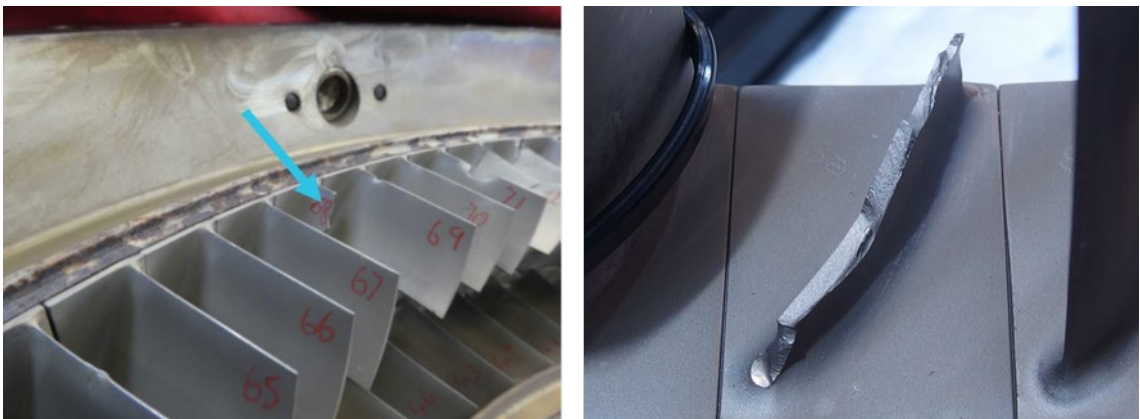
**Figure 6: Stage 6 vane fatigue failure**

The fractured stage 6 vane sustained a tear near the aerofoil root to a depth of approximately 10 per cent chord. This initiated a fatigue crack that ended 2 mm from the trailing edge with the remaining material exhibiting a material overstress signature.

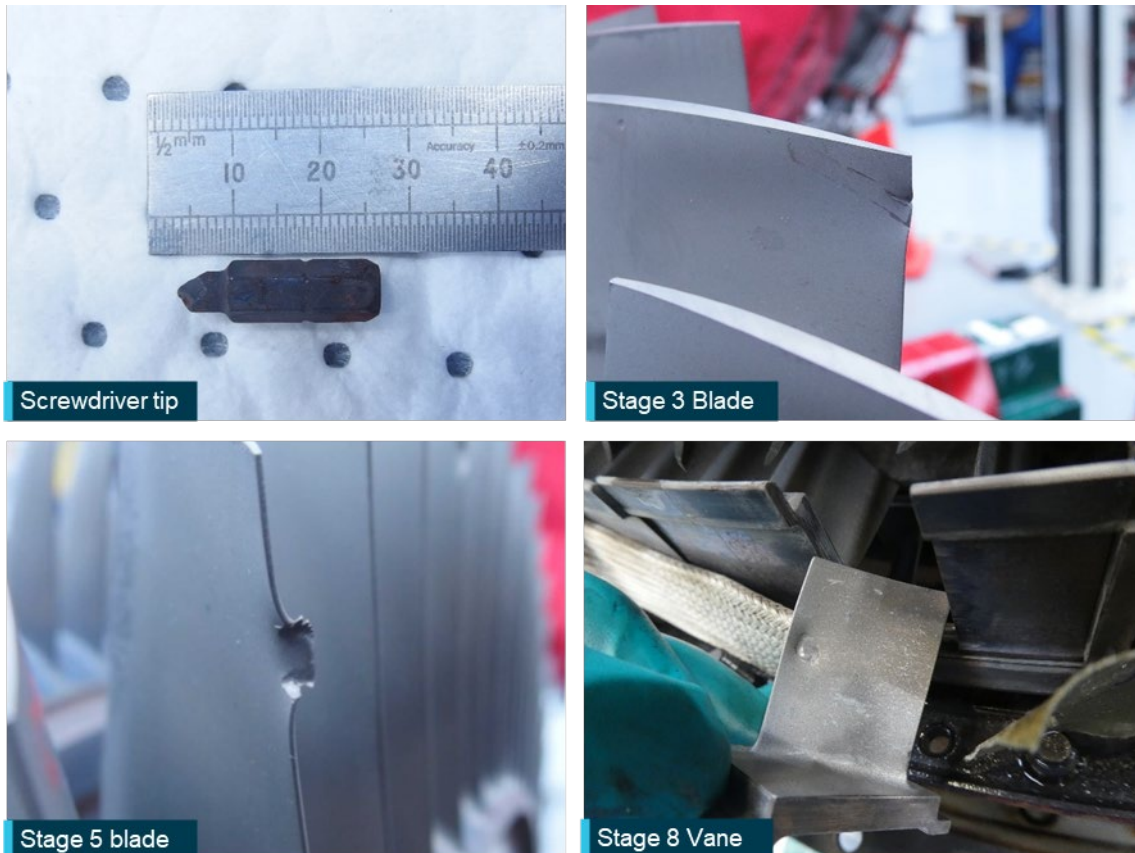
- Four stage 7 blades and one stage 8 blade were missing and had failed due to overstress. In this section all remaining blades and vanes exhibited hard body damage resulting in severe bending and tearing to both leading and trailing edges. One stage 8 vane contained a distinctive hexagon shaped dent (Figure 7).

- Small metallic debris and a ¼" hexagon drive screwdriver tool bit (screwdriver tip) was found between the combustion liner and engine case. The screwdriver tip was burnt/discoloured and the tip eroded due to heat and mechanical damage (Figure 7).
- Nozzle Guide Vane (NGV) cooling passages contained small metallic debris.
- Two stage 1 HPT blades contained leading edge nicks attributed to material impacts.
- Small debris was found throughout the LPT.

Witness marks on many components throughout the HPC matched the shape of the screwdriver tip found in the combustion section (Figure 7).

**Figure 7: Screwdriver tip and witness marks**
